## 1. INTRODUCTION

- 1.1 This archaeological assessment of the site of Woodhorn Colliery was commissioned by Northumberland County Council, prior to development works on the site, and is in line with government advice contained in Planning Policy Guidance: Archaeology and Planning (PPG16).

- 2.1 Woodhorn Colliery (grid ref. NZ 2890 8840), lies near Ashington, on the Northumberland coalfield. This coalfield occupies southeast Northumberland, its western boundary running from the coast near Warkworth, southwest to the Tyne near Ovingham and the Derwent near Shotley Bridge. To the south the coal seams continue uninterrupted into the Durham coalfield; to the east, they continue beneath the North Sea, the practical limit of the coal field being the limit of economic working from onshore collieries. The Coal Measures consist of alternating sandstones, shales, clays and coal seams, dipping gently overall to the southeast; a total of 24 coal seams have been worked (Tuck 1993, 9). Geological mapping (1", sheet 10; surveyed 1882, resurveyed 1924-6, published 1934, and reprinted 1966) indicates that the colliery site is covered by Boulder Clay drift; Upper Coal Measures were exposed to the

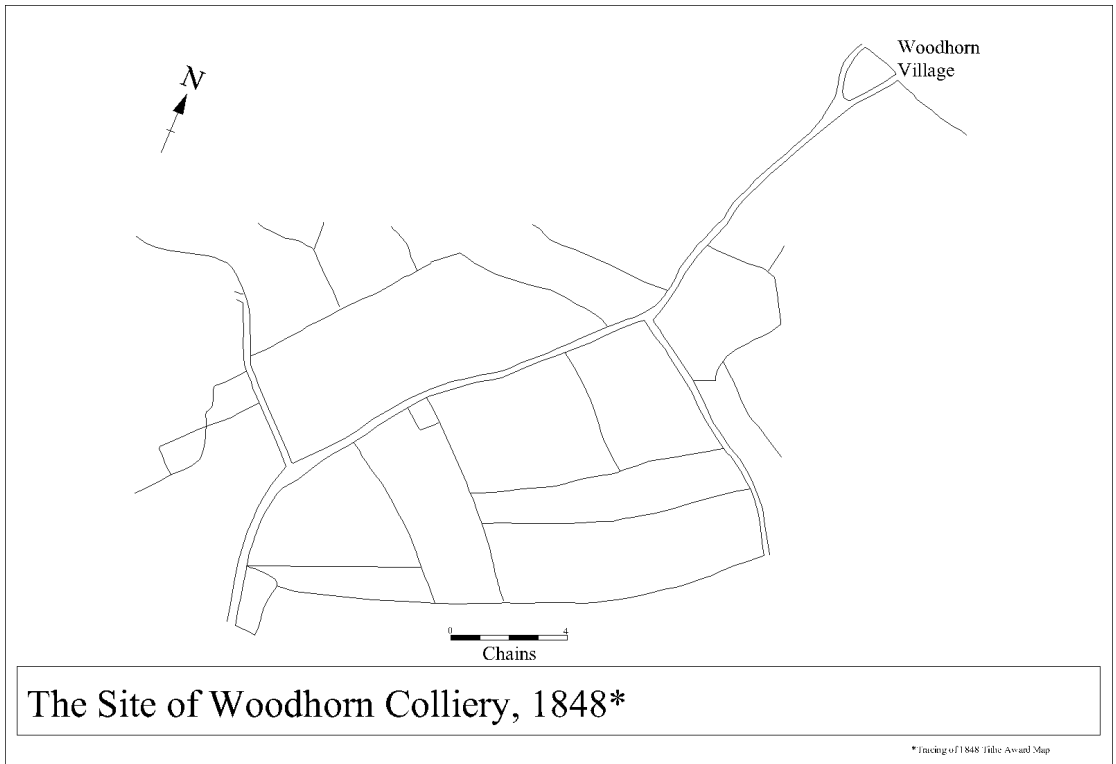
Figure 1: Site of colliery in 1848

- 3.1.1 None of the historical sources consulted give any indication of mining within, or adjacent to, the study area before 1894, and the absence of outcropping seams on the Geological Survey map argues against any mining having taken place. However, pre-19<sup>th</sup> century mining is not always recorded in any surviving documents, and the waggonway system of the immediate area (if any) is not known to have been studied. The possibility of unrecorded pre-1894 mining within the study area therefore cannot be totally excluded.

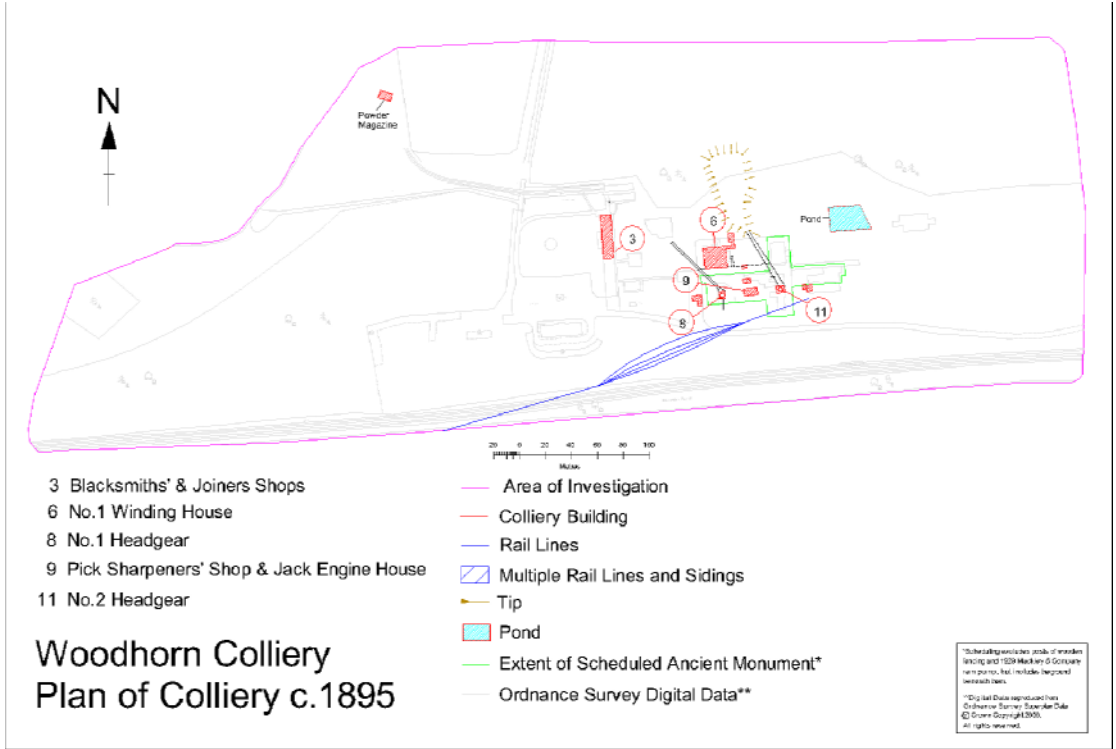
Figure 2: Plan of colliery, c 1895

- 3.1.2 Woodhorn Colliery was one of five collieries owned by the Ashington Coal Company. The company had been active in Northumberland since 1866 and went on to dominate mining in south-east Northumberland, developing into one of the largest coal producers in the country. Enclosed fields previously occupied the site chosen by the Company at Woodhorn (see Figure 1). Shaft sinking began at the Woodhorn site in May 1894, drawing coal in February 1898. By 1895, the No.1 Winder (with boilers to the rear), No.1 Heapstead (extended by 1923) and No.2 Heapstead (also extended by 1923) were in place. There were also the Blacksmiths' and Joiners' Shops (extended to the south, 1908), various other workshops, a pond to the north-east for supplying the boilers, a spoil heap to the north, a magazine to the north-west and a stretch of railway approaching the colliery from the south-west (see Figure 2). All of the buildings were constructed of yellow Ashington brick, made from the clay drawn from the shafts. The composition of the colliery by 1895 was typical of others in the region in the process of sinking shafts but yet to produce coal.

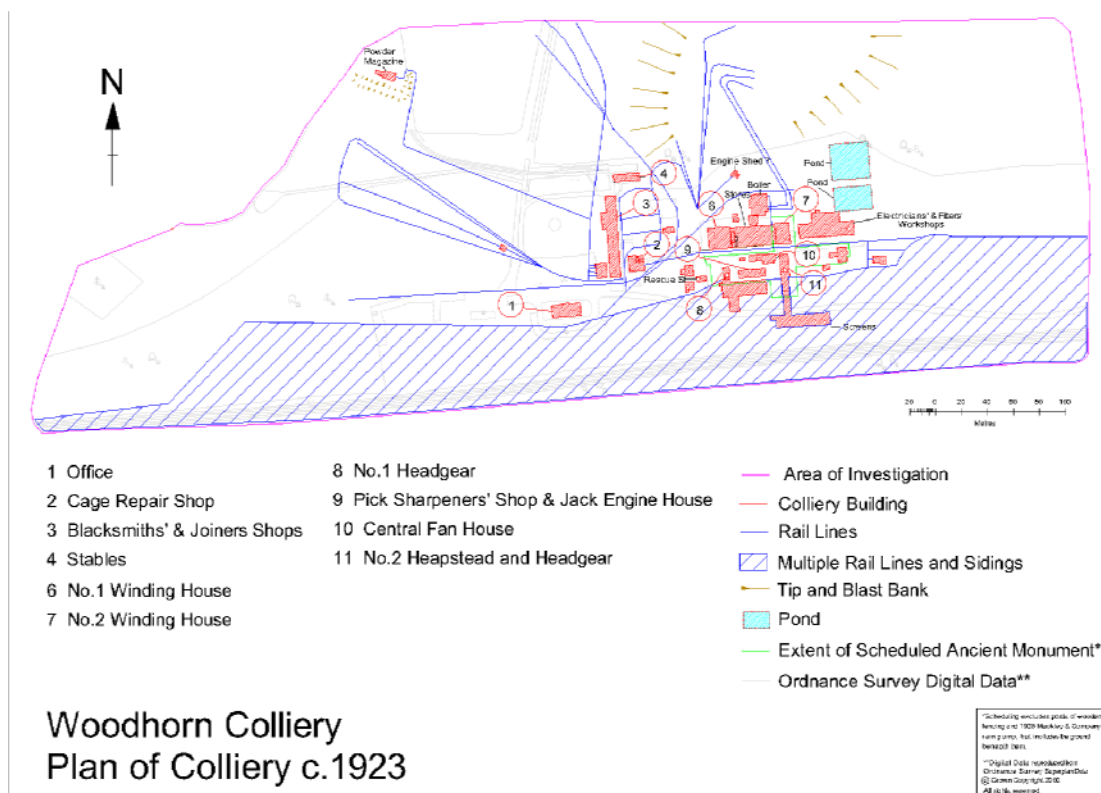
Figure 3: Plan of colliery, c 1923

- 3.2.1 By 1923 Woodhorn Colliery had developed into a well-integrated colliery, typical of the Northeast region of the late-19<sup>th</sup> century to early 20<sup>th</sup> century. The No.2 Winder would have been added early in the period, prior to coal extraction in 1901, as were the Jack Engine House (c.1900, possibly incorporating fabric from the earlier, smaller engine house), the Central Fan House (1900), Cage Repair Shop (c.1900), No.1 and No.2 Heapsteads and the Stables (c.1900). By the end of the period extensions had been added to the Blacksmiths' and Joiners' Shops, No.1 and No.2 Heapsteads, additional boilers constructed to the rear of No.1 Winder and a stores building between the No.1 and No.2 Winders. Other new buildings included the Electricians' and Fitters' Workshops, the Offices (1910) and the Screens. A second pond was also dug and the existing one extended, so as to provide the additional boilers with water. A network of railways connecting the various buildings, and the rapidly expanding spoil tip and railway sidings, completed the integrated layout of the colliery by the end of the period (see Figure 3).

The Cage Repair Shop was originally 'L-shaped' in plan. A smaller square building was located at the inside angle of this building (see Figures 3 and 4). A further building was also located immediately to the west of the southern end of the Blacksmiths' and Joiners' Shops.

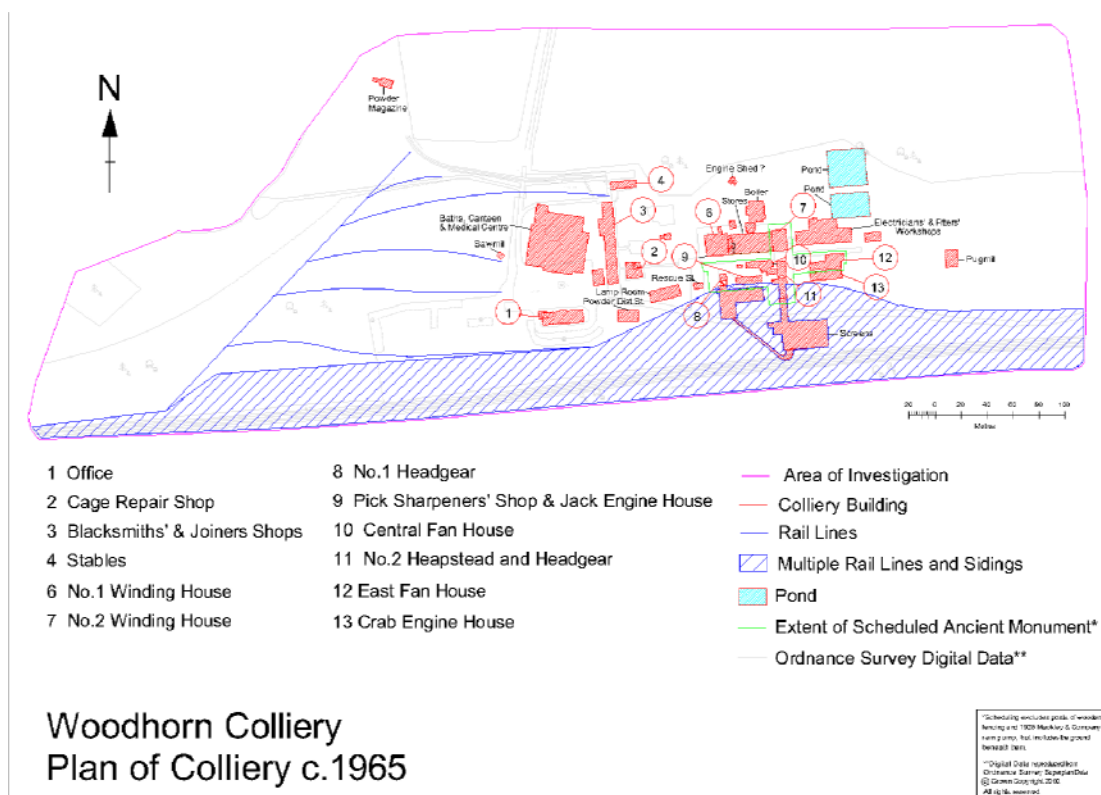
Figure 4: Plan of colliery, c 1965

- 3.3.1 The colliery during this period, unlike many other collieries in the region, underwent relatively little development. The large block of pithead baths, canteen and medical centre were opened in March 1930, providing 1,152 clean clothes lockers, 1,152 pit clothes lockers and 64 bath cubicles. Other new buildings constructed included the Powder Distribution Station, Lamp Room, Pugmill, the East Fan House and Crab Engine and Compressor; the latter two were constructed on the sites of two buildings of the preceding period. A number of buildings were extended, including the Offices, Screens and No.1 Winder, and the No.1 Heapstead was altered. A number of alterations were also made to the network of railways, some stretches being removed and new stretches added, particularly to the west of the Baths (note that the apparent lack of railways interconnecting the various buildings may be due to omissions of the surveyors, rather than due to their removal or absence, see Figure 4). No plans which identify the extent of the spoil tip could be located for this period, and so no suggestions are made as to its development.

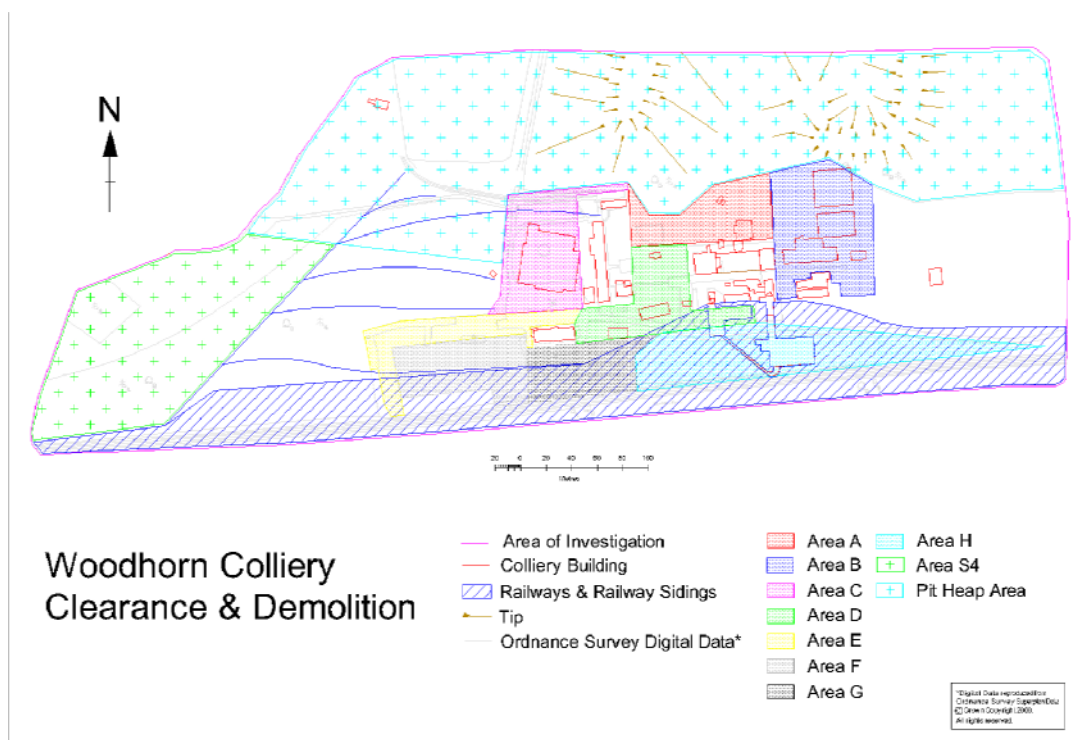
Figure 6: Clearance and demolition – contract areas

- 4.1.1 The Ashington Reclamation Scheme was introduced in 1974. The aims of the scheme included the reclamation of one square mile of dereliction associated with the former Ashington and Woodhorn collieries. It was intended to provide new woodland, farmland and parkland, an amenity lake, a museum/crafts centre, hotel and business park. The reclamation of the former Woodhorn Colliery embraced the pithead complex, spoil heaps and associated despoiled land and involved a number of phases of demolition and landscaping between 1974 and 1985. For the purposes of reclamation the site was divided up into zones, identified in contemporary documents as areas A to H, S4 and Pit Heap (see Figure 6).

- 4.1.2 The bills for the reclamation of each zone provide information on the precise reclamation strategy for each area, and therefore for the prospects of modern below-ground survival. While the details differ, the overall picture is consistently that all foundations and hard surfacings were to be broken up, and therefore that the prospects for meaningful stratigraphic survival within these areas is poor.

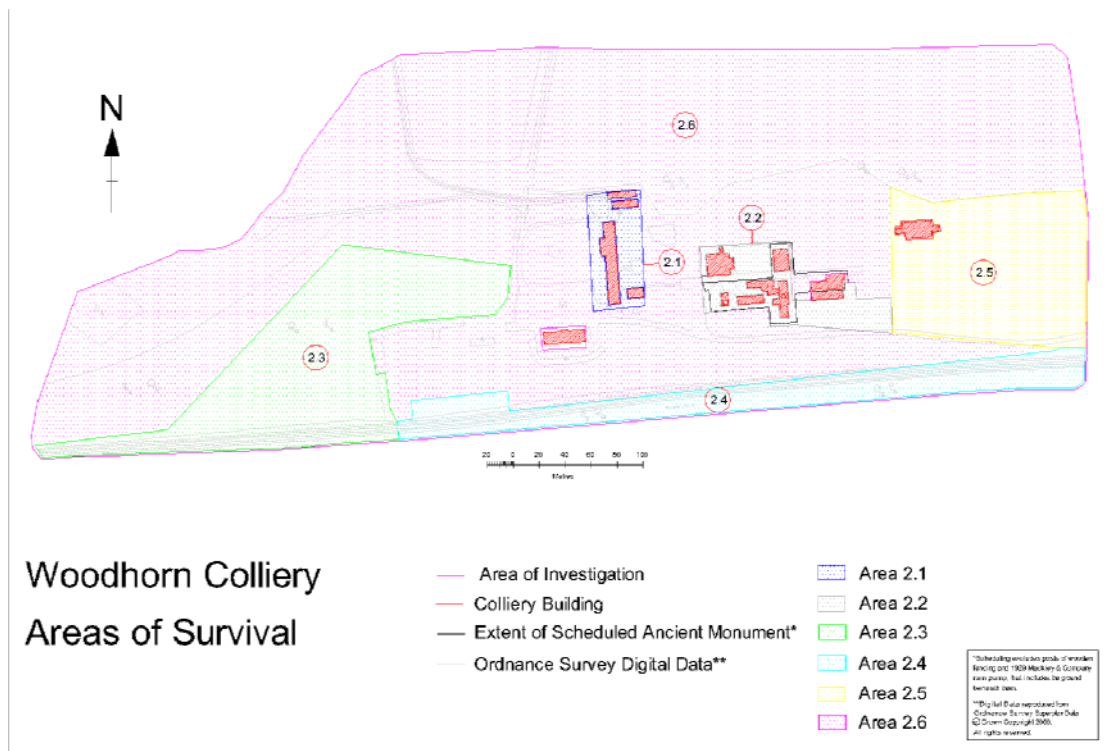
Figure 7: Plan of colliery, 2000, with area numbers

## 5.2 The remainder of the site (Figure 7)

Since the assessment has indicated that most former buildings and structures were either within the footprint of the existing Listed Buildings and Scheduled area, or within areas where their remains are likely to have been destroyed by reclamation, the gazetteer is kept very simple.
